Oracle Server X7-8 Product Notes

E71927-17
November 2022

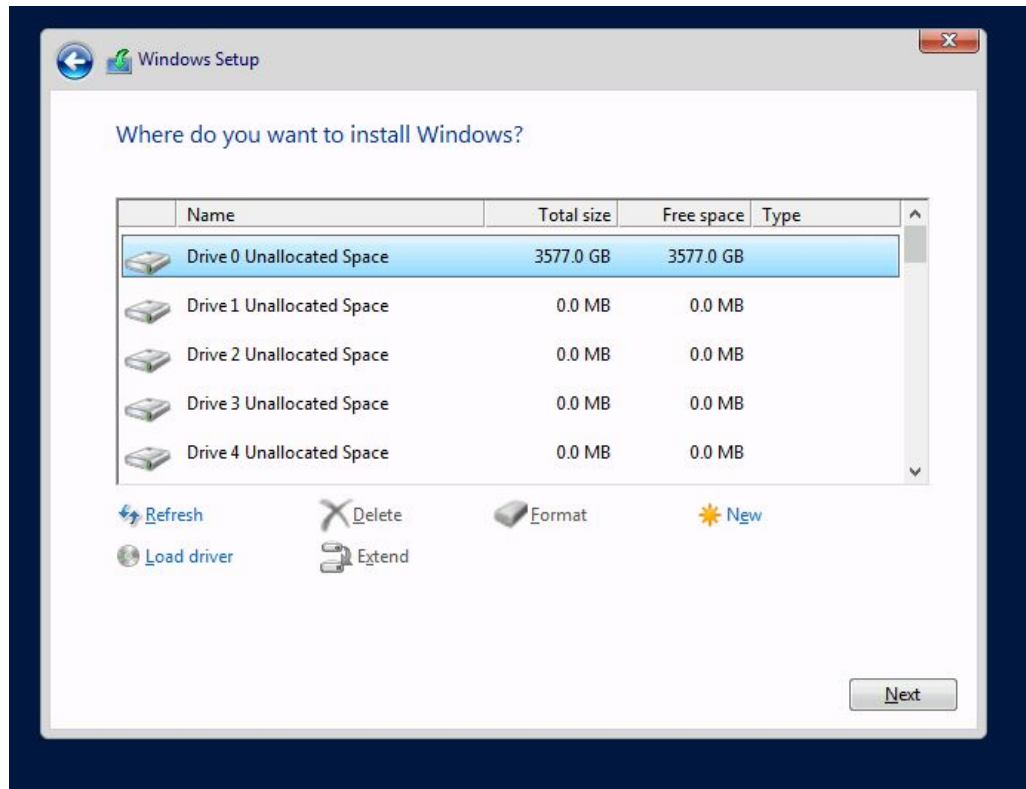
Bug ID: 32158109

Issue: During Windows Server 2016 installation on a system with an NVMe storage drive, Windows Setup lists the NVMe storage device and 127 phantom listings of the same NVMe storage device. These phantom storage devices each show a total size and free space of 0.0 MB. For example:

After you install Windows Server 2016, the 127 phantom drives also appear in Windows Device Manager. This issue is due to an out-of-date inbox Windows Server 2016 NVMe driver that does not support the multiple namespace feature of some NVMe storage devices.
